Hamilton Center
1401 Brentwood Parkway NE
Washington, DC

Comprehensive Facility Condition Assessment
And Space Utilization Study
DCAM-12-NC-0158

May 13, 2013

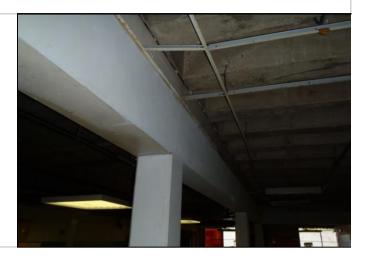
Asset Photo: B10 SuperStructure.1

Concrete superstructure:

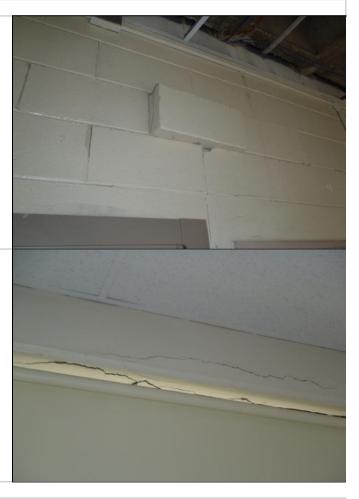
Asset Photo: Cracking CMU and Concrete Walls.1

Shifting CMU block wall classroom 324:

Cracking CMU and Concrete Walls

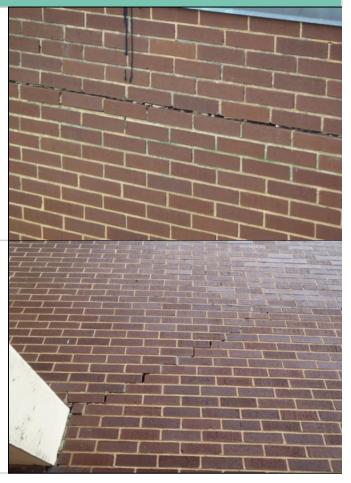
Asset Photo: Repair and Repoint Brick Masonry Exterior Walls.1

Missing mortar at brick masonry east side of building:

Repair and Repoint Brick Masonry Exterior Walls

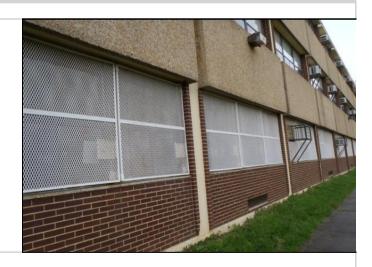
Asset Photo: Paint Exterior Metal Grates at Windows.1

Metal grates covering at windows:

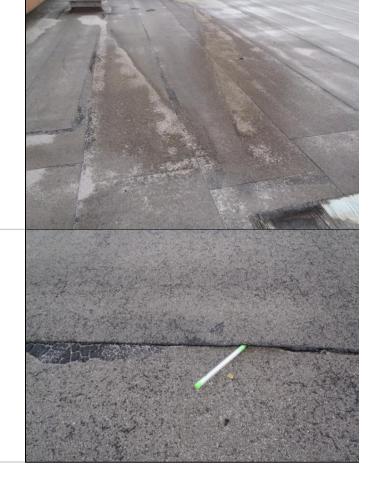
Asset Photo: Modified Bitumen - Single Ply.2

Condition of roof:

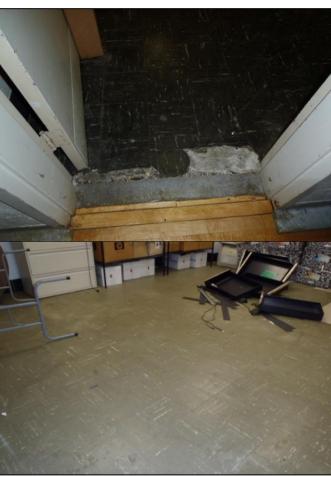
Asset Photo: Vinyl Tile Flooring.1

Damaged 9X9 vinyl tile stage dressing room:

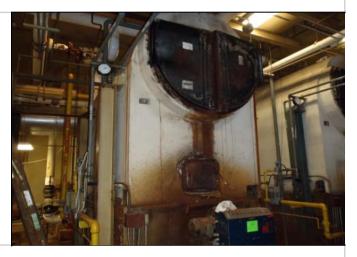
Asset Photo: Central Heating Boiler 2.1

Heating boiler 2:

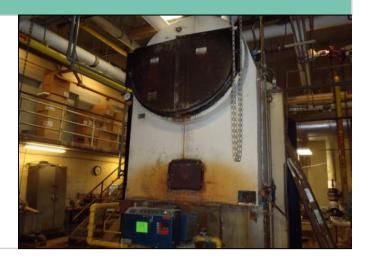
Asset Photo: Central Heating Boiler 1.1

Heating boiler 1:

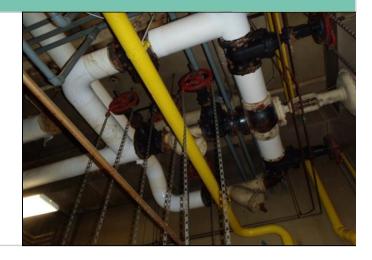
Asset Photo: Boiler Room Piping & Valves.2

Leaking pipe/valve in boiler room:

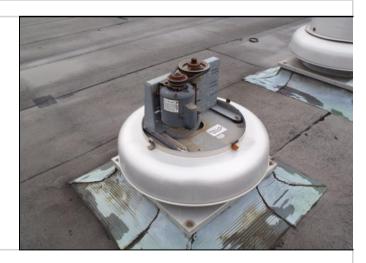
Asset Photo: Centrifugal Roof Exhaust Fan Systems.1

Roof exhaust fan missing cover:

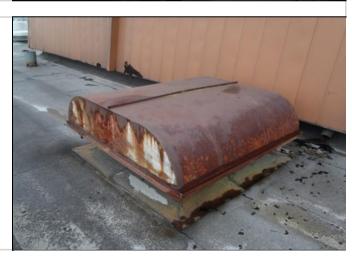
Asset Photo: Metal Exhaust Hoods.1

Rusting roof exhaust hood:

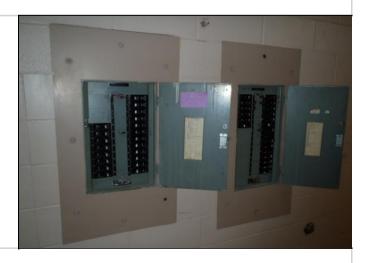
Asset Photo: Panelboards - 120/208volts, 200amp.1

Original FPE electrical panels:

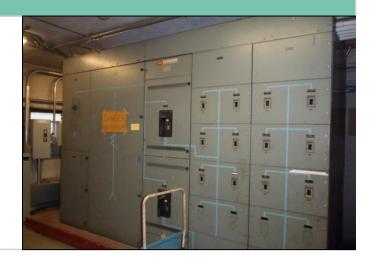
Asset Photo: Main Electrical Switchgear.1

Original FPE electrical switchgear:

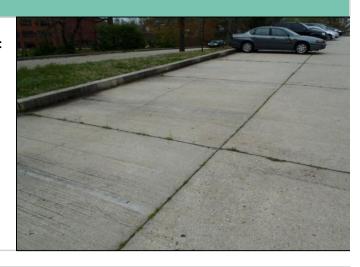
Asset Photo: Restripe Parking Lot.1

Worn pavement markings at rear parking lot:

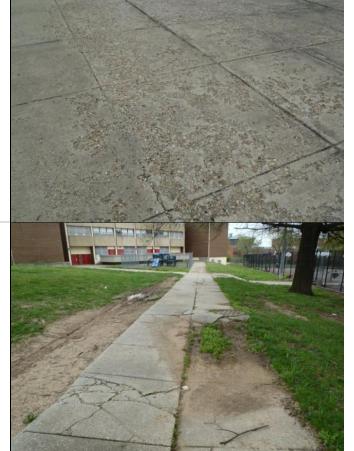
Asset Photo: Cracking and Spalling Concrete Sidewalks.1

Spalling concrete sidewalks front of school:

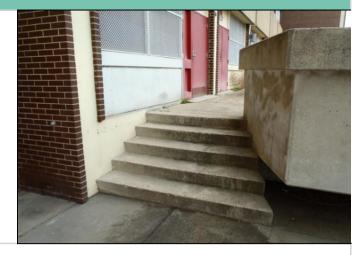
Asset Photo: Install Metal Handrails at Site Steps.1

Missing handrail at steps west side of building:

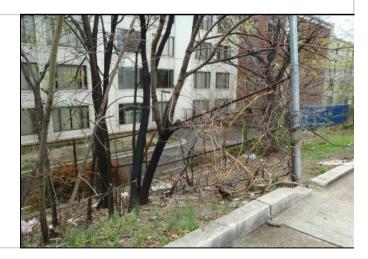
Asset Photo: Chain Link Galvanized Fence.1

Condition of site chain link fencing:

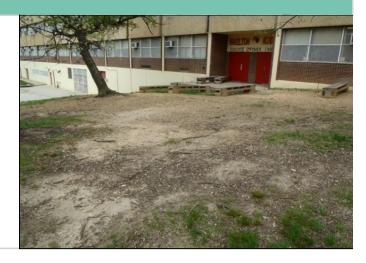
Asset Photo: Re-grading landscape and establishment of ground cover .2

Bare soils at landscaping south side of school:
