Draft Report of Condition Assessment

P.R. Harris Education Center Washington, DC

FEA Project No.: R01.2008.005662

**SUBJECT: Report of Facility Condition Assessment
District Elementary & Middle Schools (Cluster II) – P.R. Harris Education Center
Washington, D.C.
FEA Project No. R01. 2008.005662**

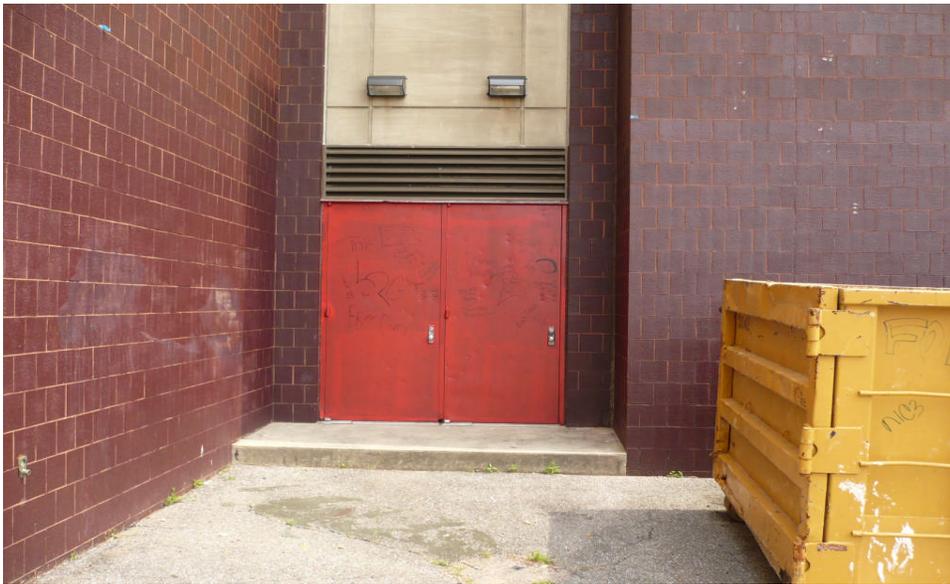
PHOTOGRAPH 2.1:
Typical Exterior Finishes -
Brick & Pre-Cast Concrete
Panels

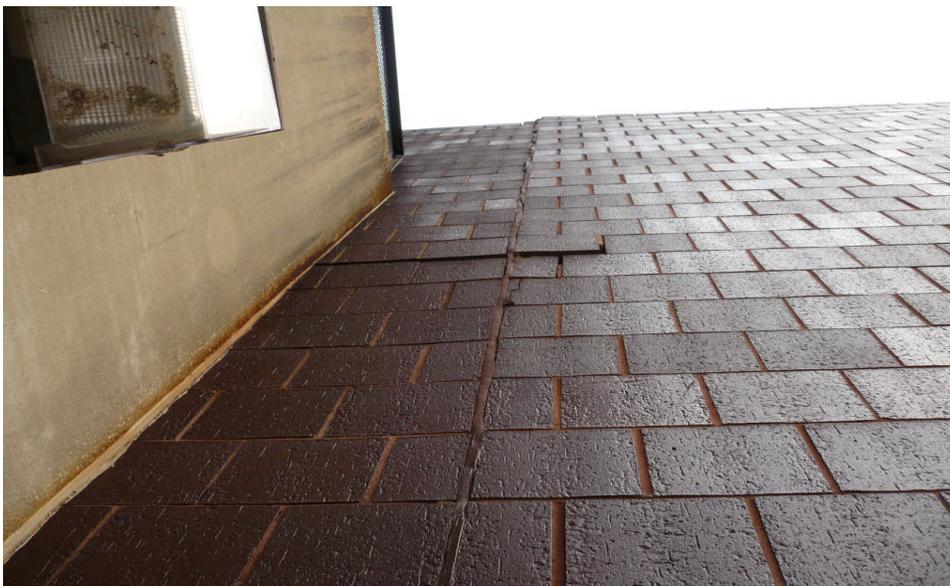
PHOTOGRAPH 2.2:
Warped Exterior Wall
System

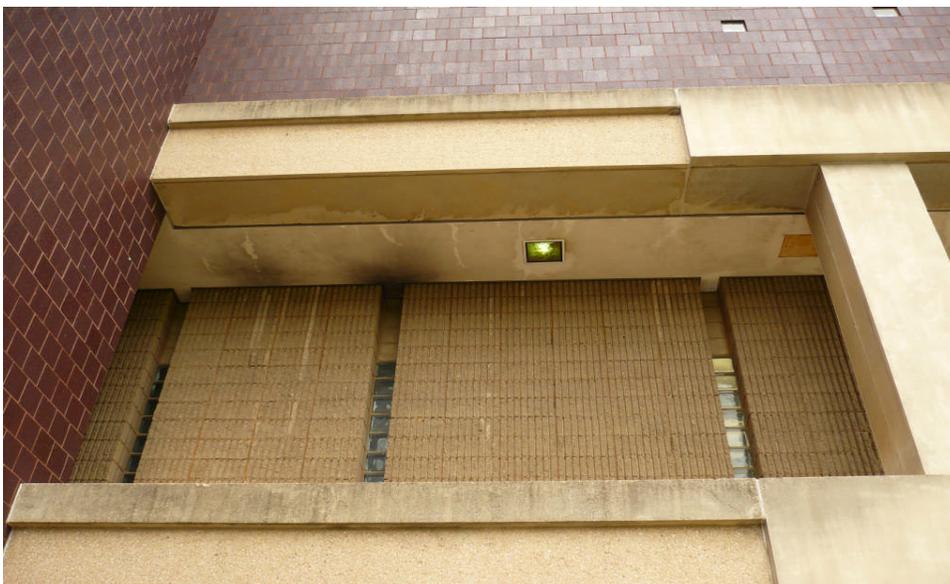
Glass block side lights	Security screens require painting. Approximately 10 units are either damaged or dislodged and require replacement.
Doors	
Metal entry doors	Generally in poor condition except for main entry. Several doors and frames were corroded or damaged. All required painting.
Access doors (second level)	Fair condition.
Overhead rollup door	Good condition.

PHOTOGRAPH 2.3:
Glass Block "Window"
System - Missing Block in
Several Areas

- a. General tuckpointing and joint repair of brick masonry exterior to include 35,250 square feet of exposure. Our opinion of the cost to perform this work is **\$564,000**.
- b. Joint replacement of the precast concrete panels to include approximately 4,000 linear feet of joint replacement. Our opinion of the cost to perform this work is **\$16,000**.
- c. Repair of concrete spalls in the precast concrete panels to include approximately 50 square feet of repair. Our opinion of the cost to perform this work is **\$3,750**.
- d. Reset precast concrete column covers. Investigate possible cause of movement. Our opinion of the cost to perform this work is **\$7,500**.
- e. Replace glass block side light units to include 10 11-block units. Our opinion of the cost to perform this work is **\$8,000**.

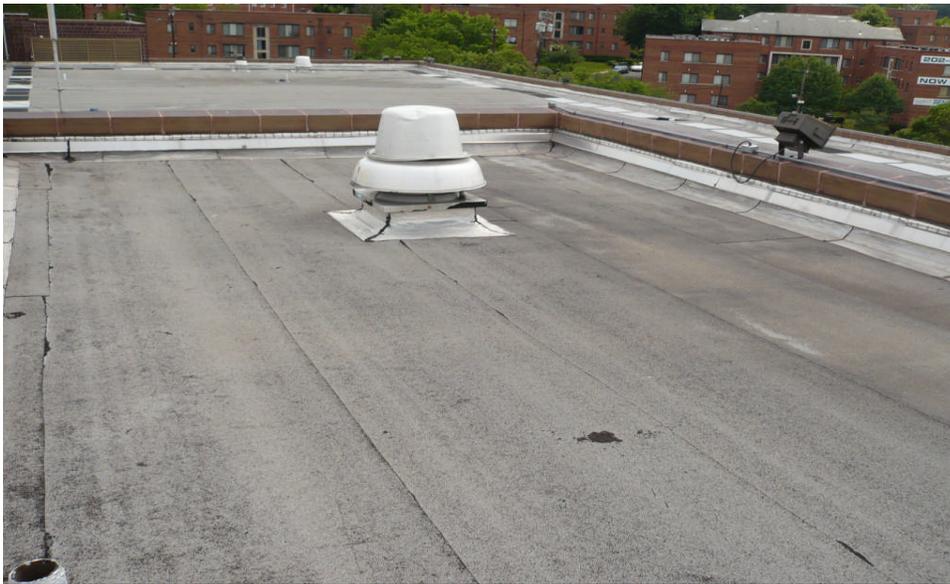
Item	Condition
Building Name	P.R. Harris Education Center
Roof Covering	
Main roof	Fair condition. No active leaks reported. No blisters or seam separations observed. Drains clear and functional. Perimeter stripping plys in poor to fair condition. Many previous repairs observed. Mortar joints of brick masonry units that cap the parapet wall are a source of continuous leakage.
Large gymnasium	Same condition as main roof.
Small gymnasium	Same condition as main roof.
Auditorium	Same condition as main roof.
Terrace	Condition unknown
Exit stairways	Good condition.
Roof Openings	
Exhaust fans	Stripping plys are in poor to fair condition.
Other	
Access ladders	Significant surface corrosion observed.

PHOTOGRAPH 2.4:
Roof Membrane - Fair
Condition

- a. Replace main roof at the end of the predicted useful life, estimated to be in five years. Our opinion of the cost to perform this work is **\$1,127,640**.

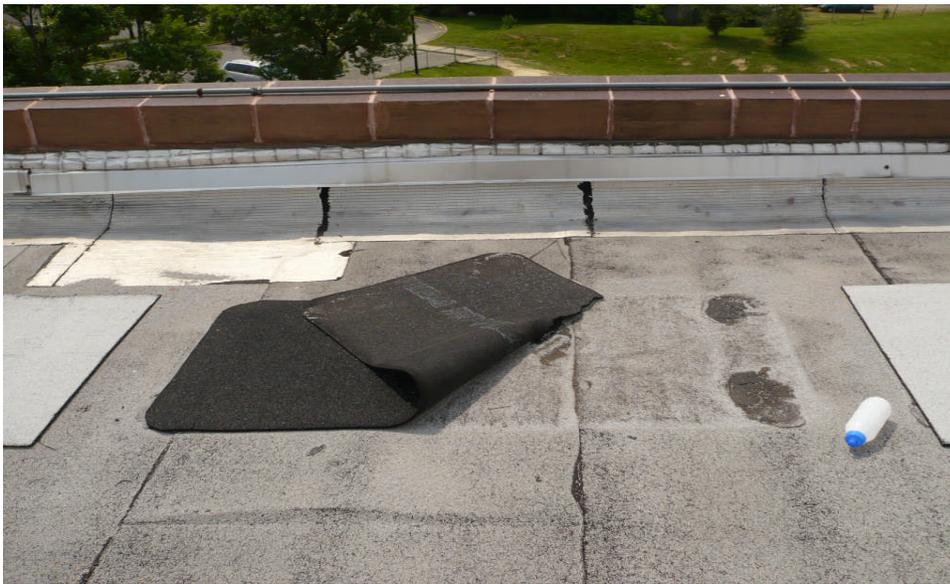
PHOTOGRAPH 2.5:
Typical Roof Conditions

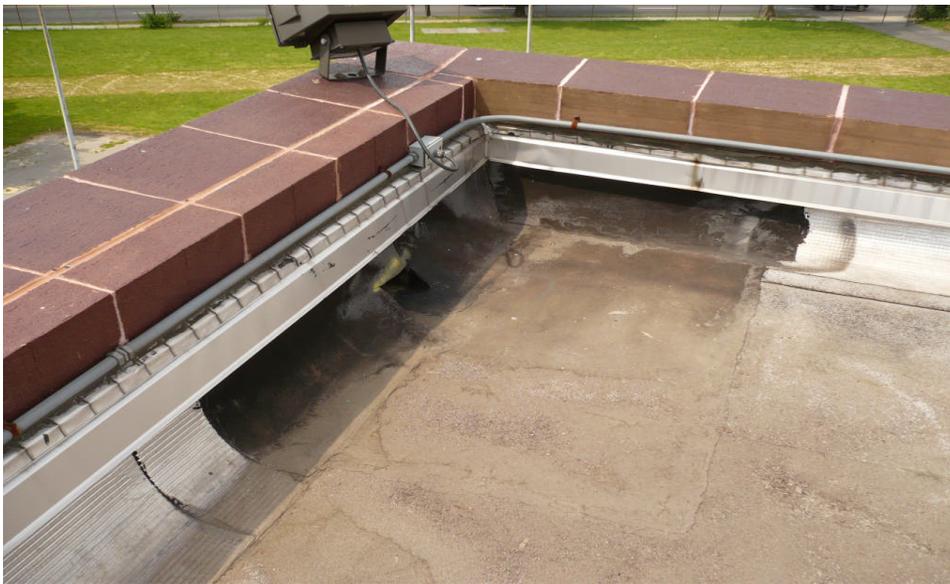
PHOTOGRAPH 2.6:
Roof Parapet/Flashing
Termination - Inadequate
Termination Continues to
Cause Leaks

- a. Allowance **\$10,000** for annual maintenance of perimeter and curb flashing elements and general roof repairs until replacement of roof systems.
- b. Re-painting of roof access ladders. Our opinion of the cost to perform this work is **\$1,500**.

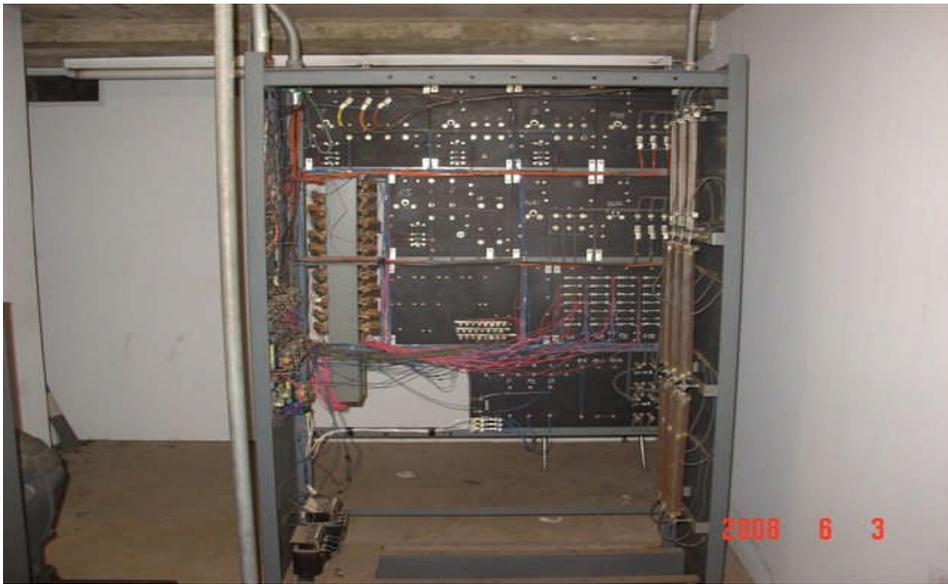
PHOTOGRAPH 4.1:
Elevator Controller (Rear
View)

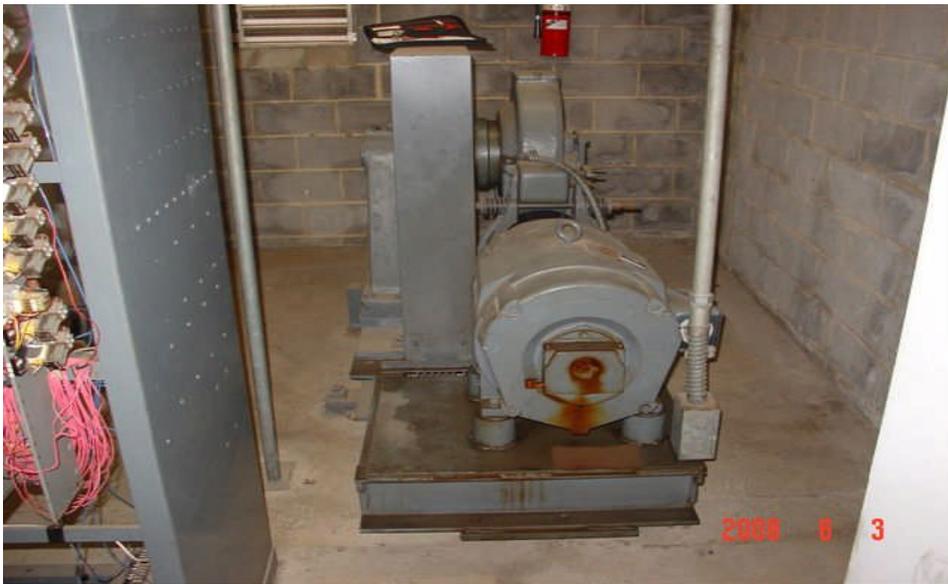
PHOTOGRAPH 4.2:
Elevator Machine

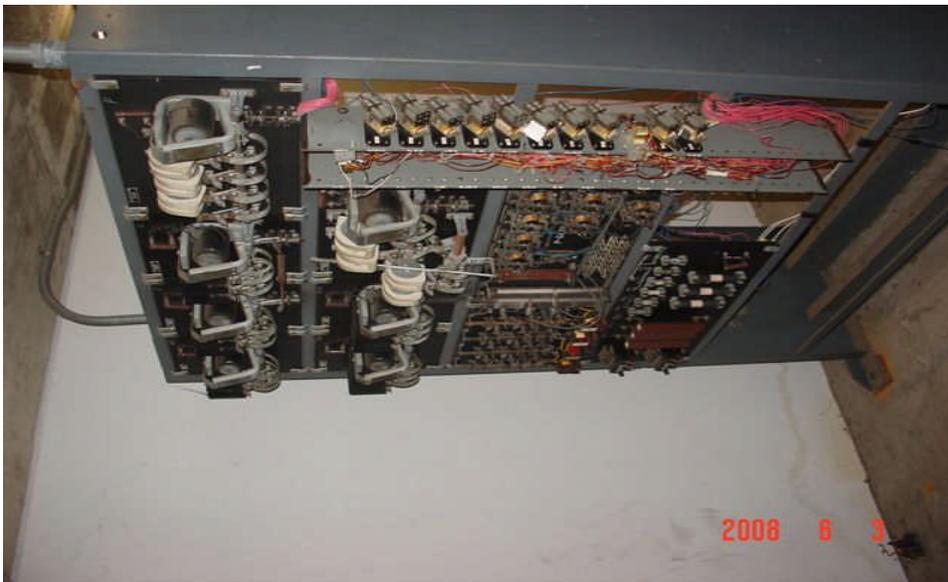
PHOTOGRAPH 4.3:
Elevator Controller (Front
View)

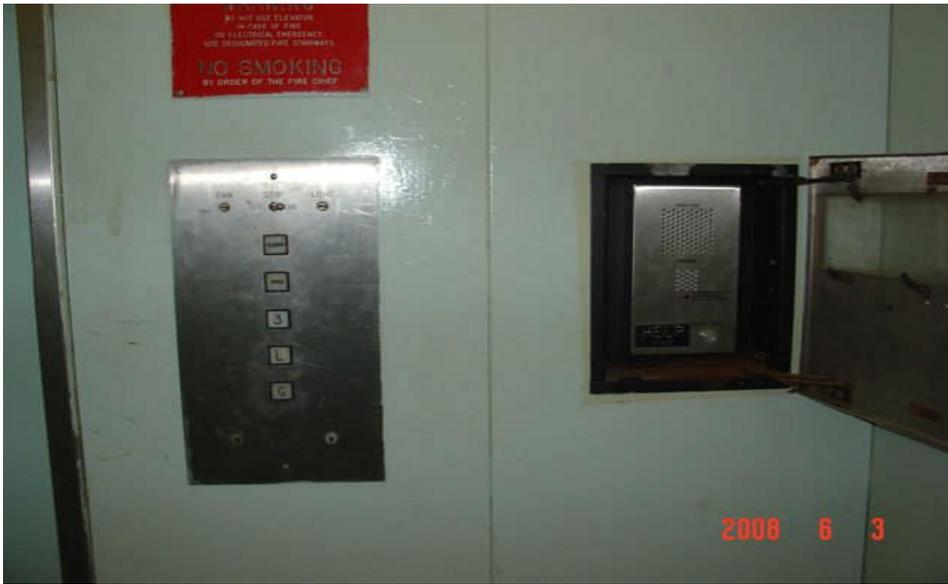
PHOTOGRAPH 4.4:
Elevator Car Operating
Panel and Phone (Non-ADA)

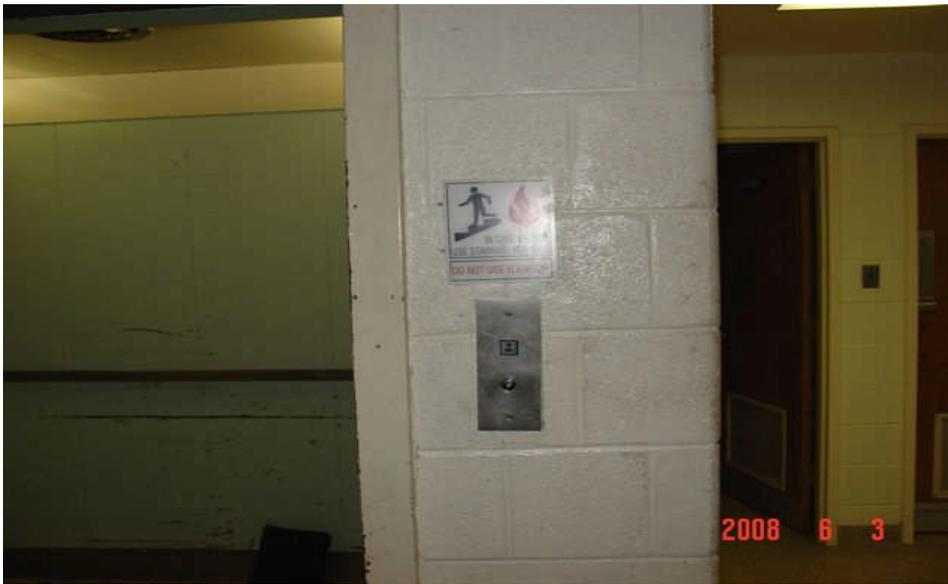
PHOTOGRAPH 4.5:
Elevator Hall Call Button -
Key Operated (Non-ADA)

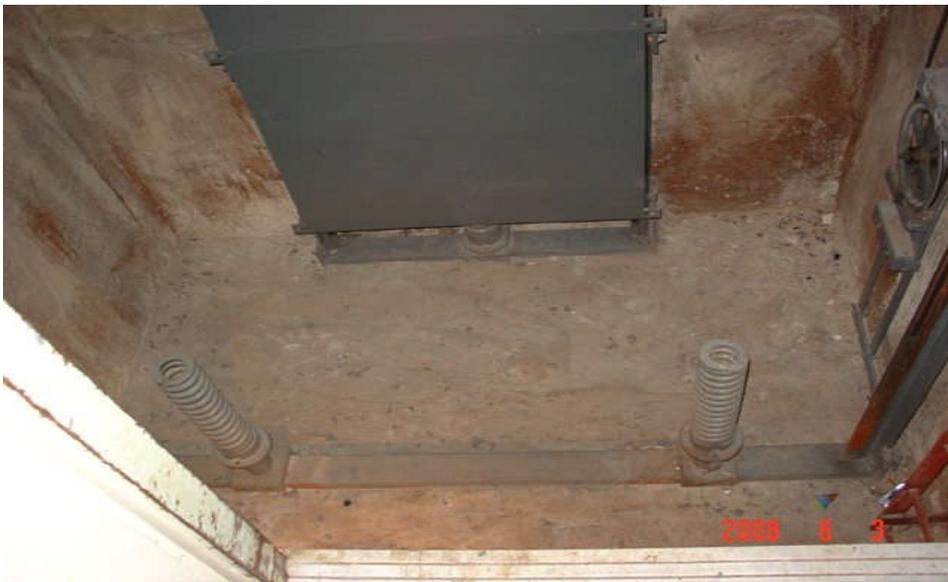
PHOTOGRAPH 4.6:
Elevator Pit

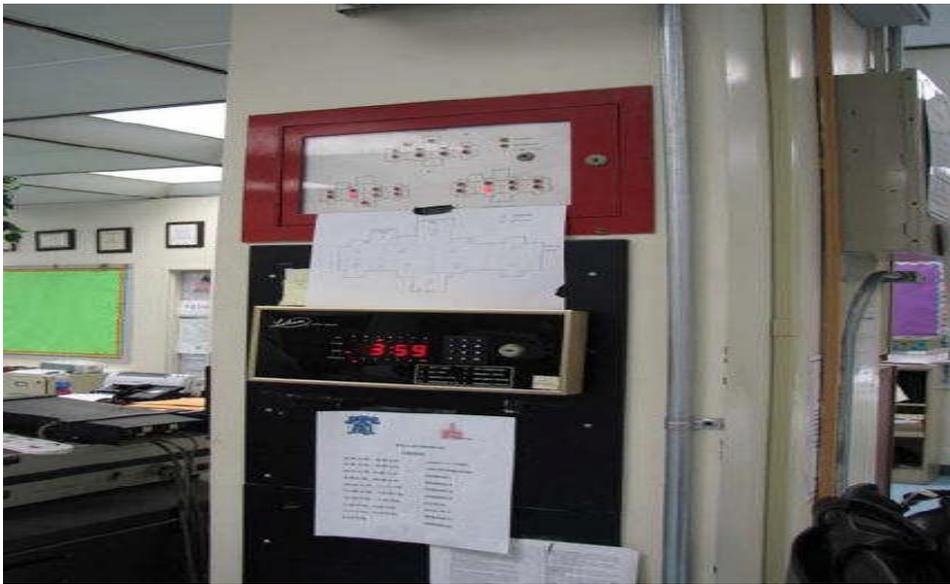
The existing Fire Alarm System was in a Trouble condition and showed two fire alarm zones in an Alarm condition. The audible and visual notification functions of the fire alarm system did not meet current code requirements. Only the Trash Room is currently provided with automatic sprinkler protection. Some exit doors and fire resistance rated doors require maintenance and changes to hardware.

PHOTOGRAPH 4.7:
Obsolete Fire Alarm
System - Replace

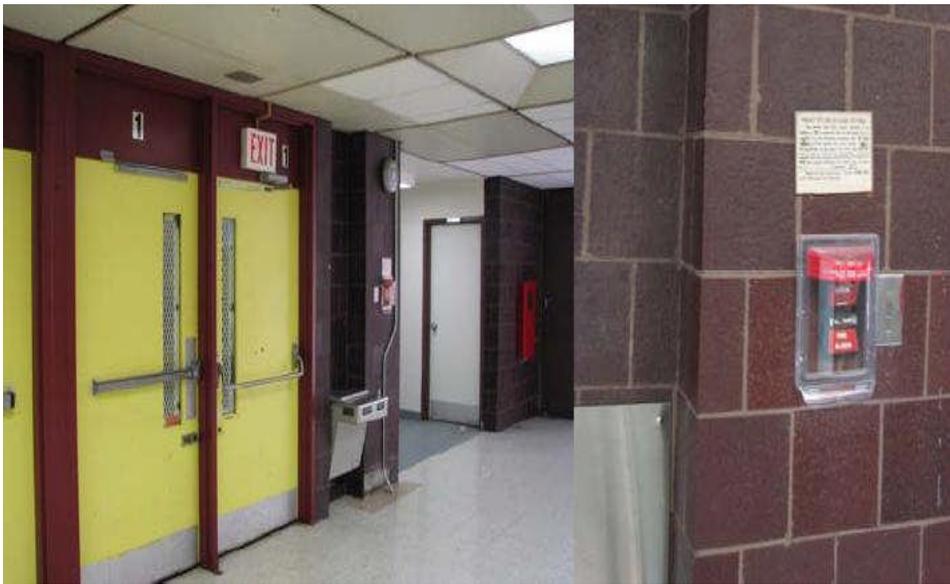
PHOTOGRAPH 4.8:
Typical Pull Stations - Lower

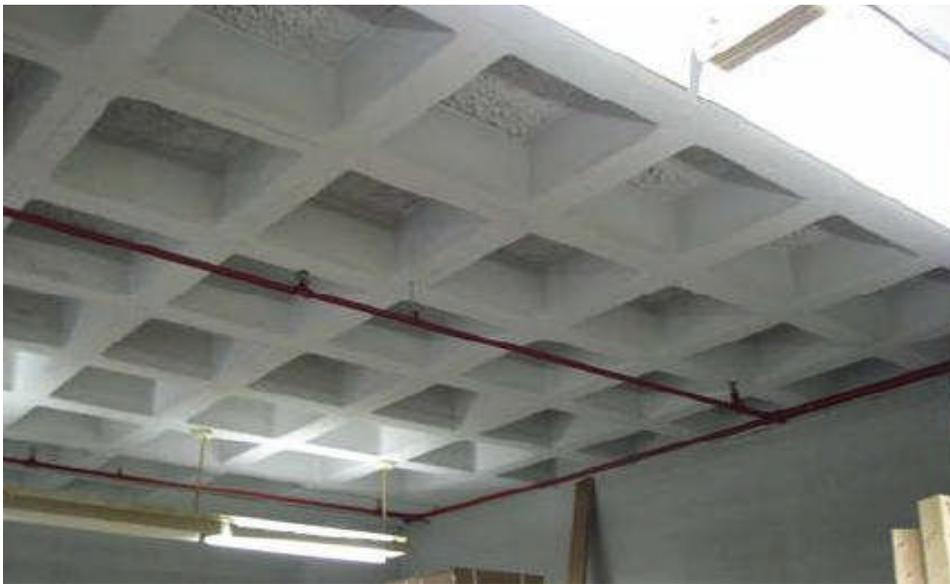
PHOTOGRAPH 4.9:
Only Sprinkler System in
the Building Located in the
Trash Room

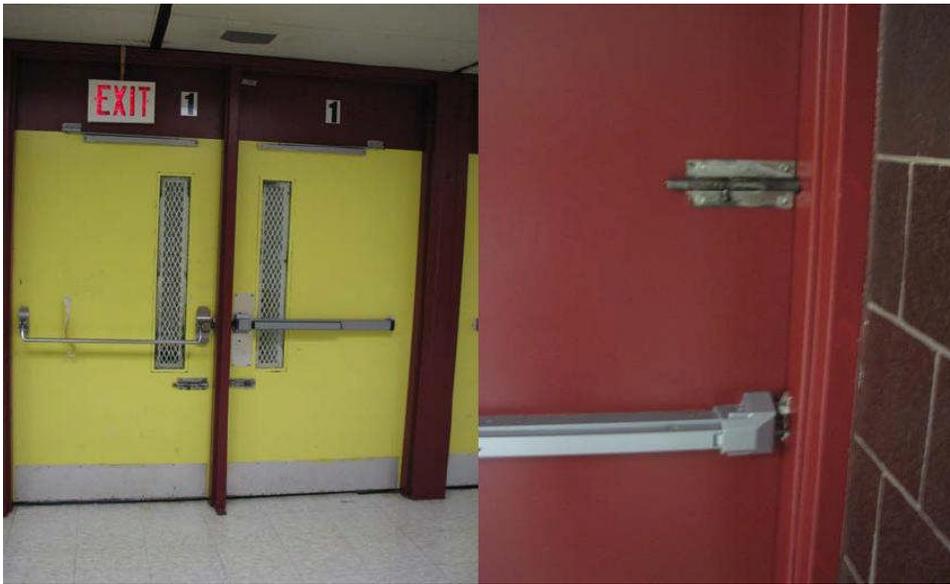
PHOTOGRAPH 4.10:
Typical Dead Bolts on Exit
Doors - Remove

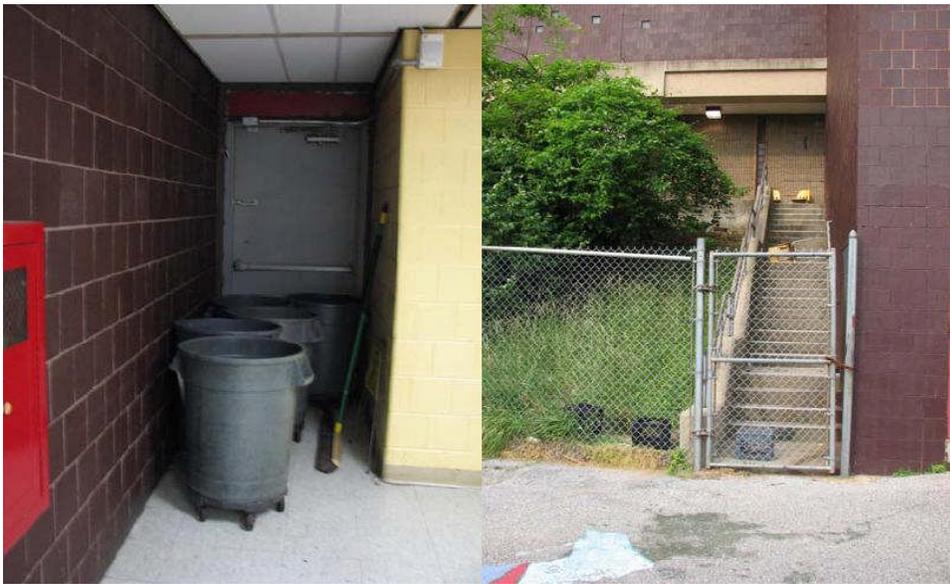
PHOTOGRAPH 4.11:
Obstructed Fire Egress -
Clear Exit

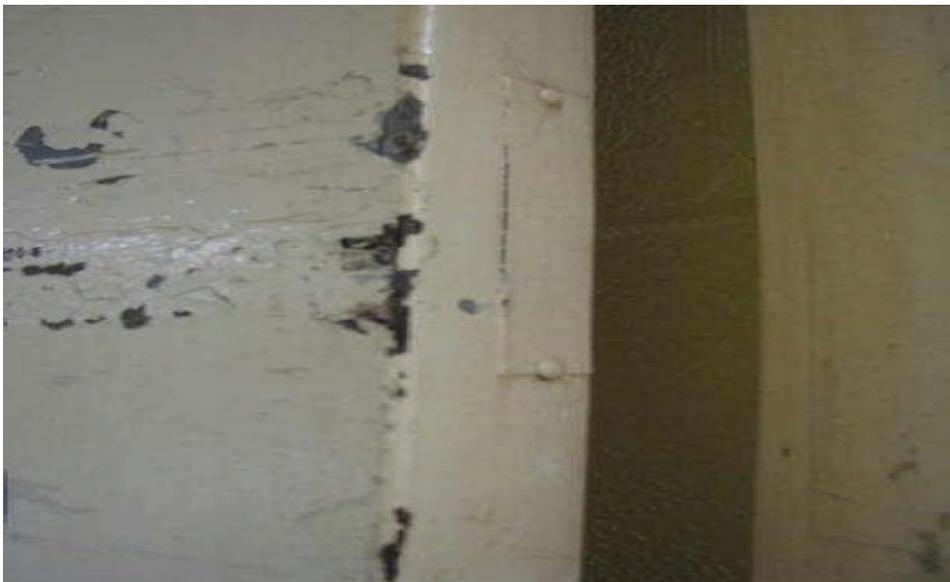
PHOTOGRAPH 4.12:
Painted Fire Rated Door
Plates - Remove Paint

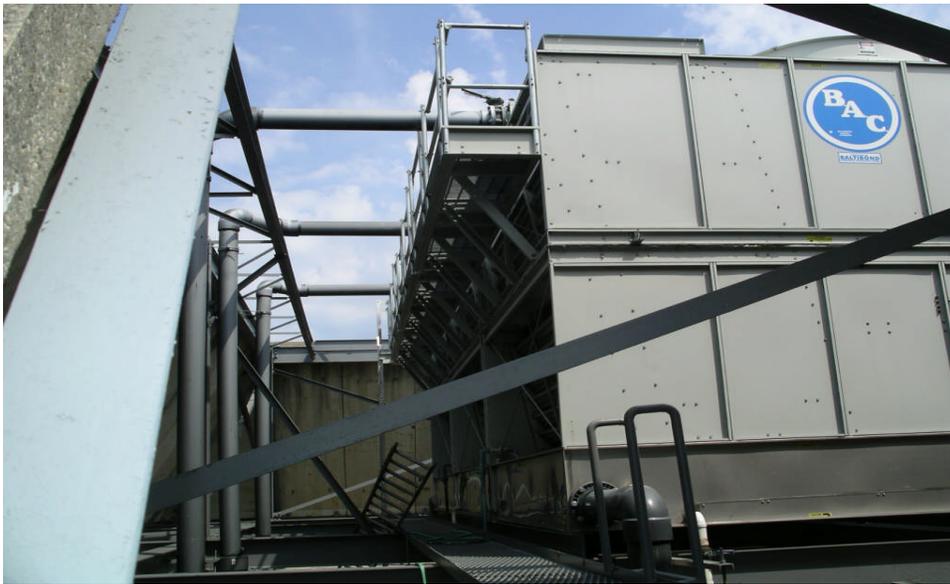
PHOTOGRAPH 4.13:
Cooling Tower on Roof

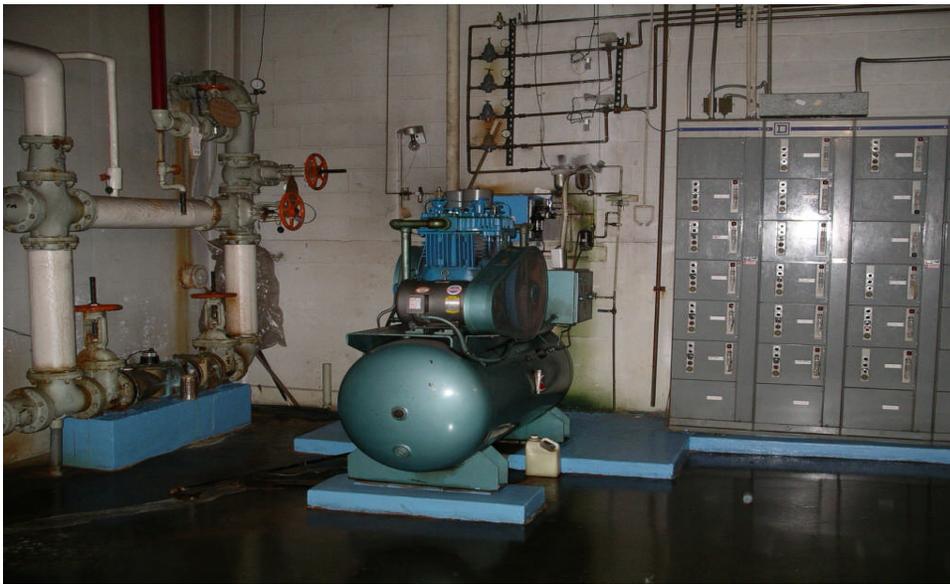
PHOTOGRAPH 4.14:
New Chiller (Less than 5
Years Old)

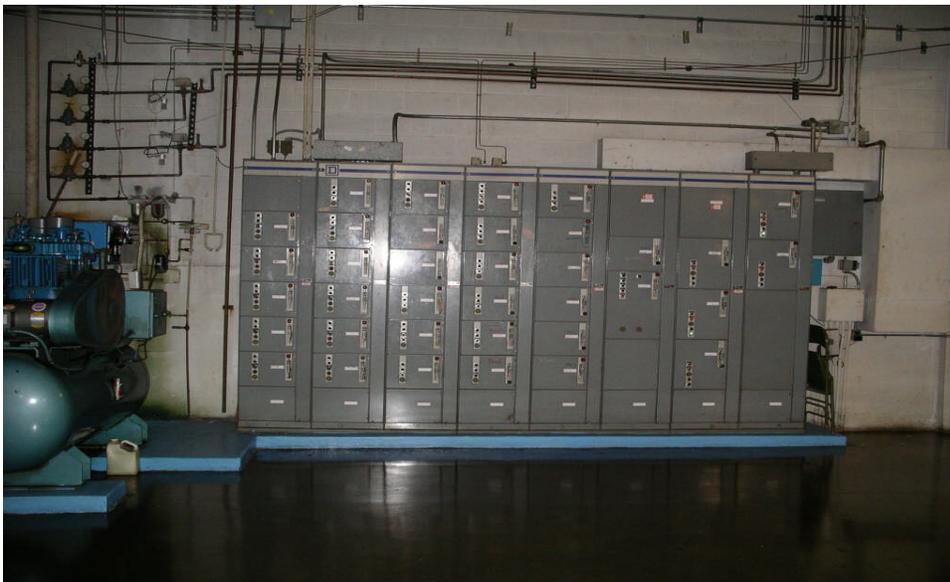
PHOTOGRAPH 4.15:
Motor Control Center

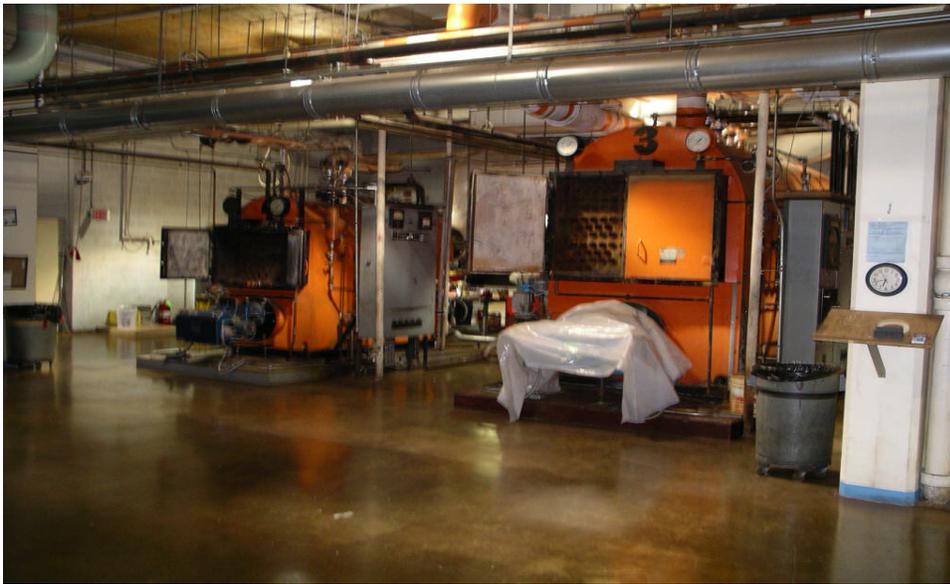
PHOTOGRAPH 4.16:
Boilers - Maintenance
Ongoing During Visit

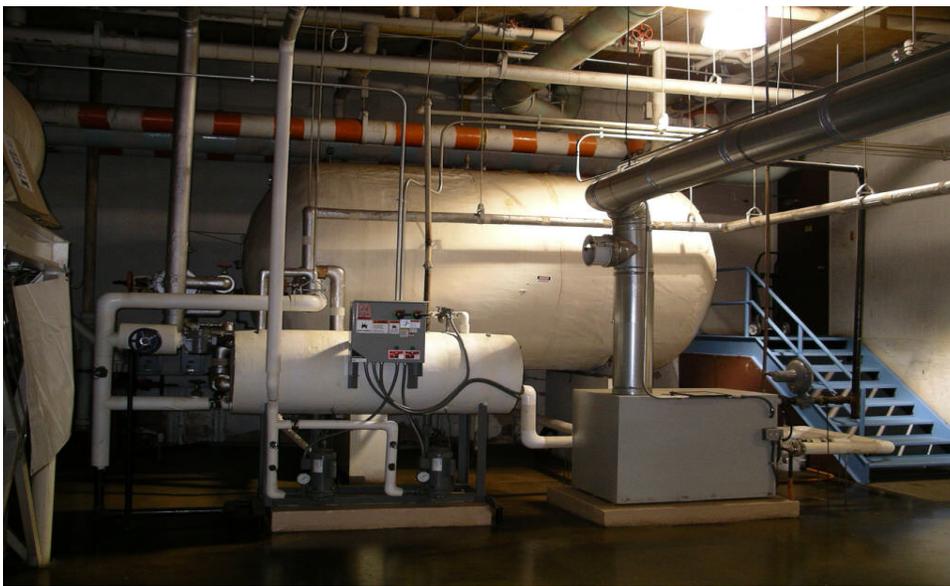
PHOTOGRAPH 4.17:
Tank for Hot Water Storage

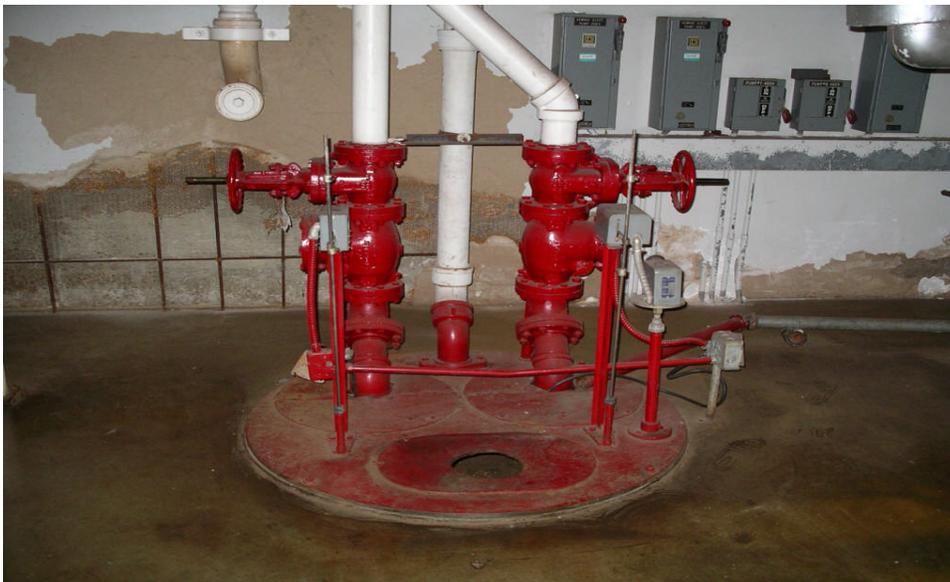
PHOTOGRAPH 4.18:
Duplex Pumping System

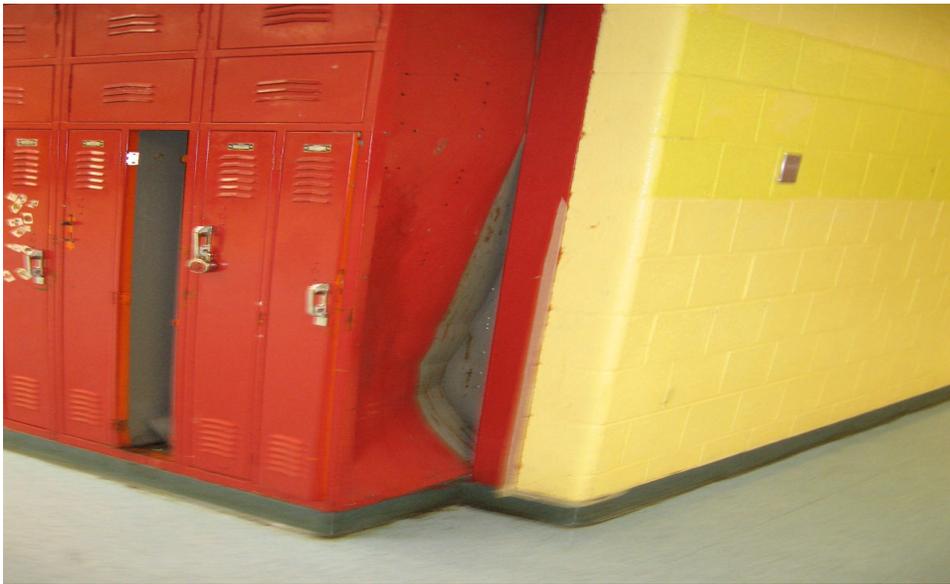
condition of most of the lockers, it was recommended that all lockers are replaced as a capital expenditure.

PHOTOGRAPH 5.1:
Damaged Metal Lockers

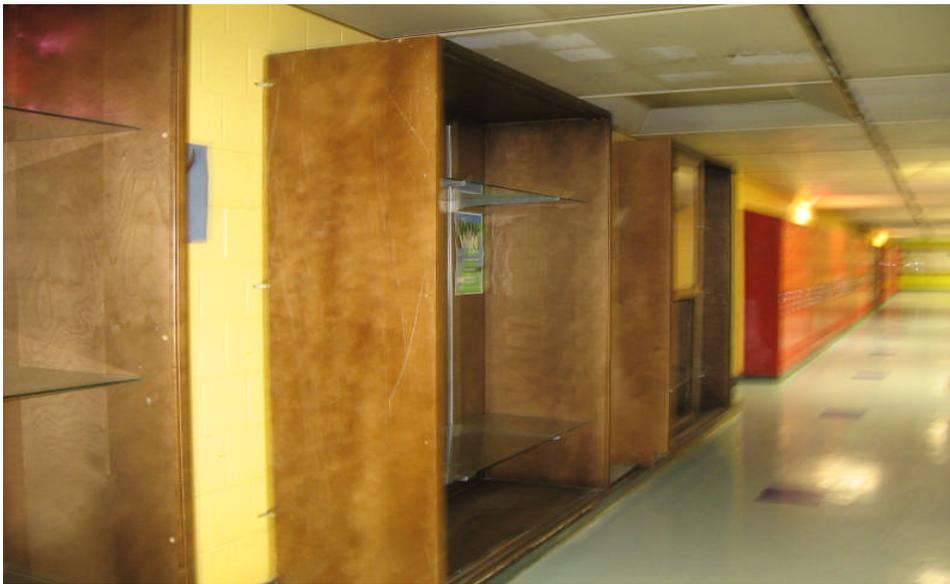
PHOTOGRAPH 5.2:
Wood Cases Along Hallway

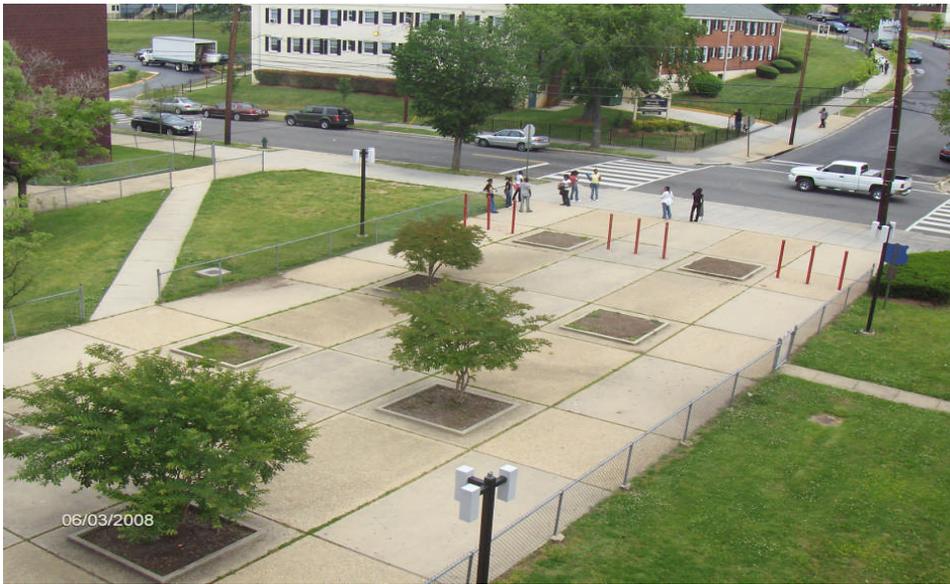
PHOTOGRAPH 7.1:
Front Entry

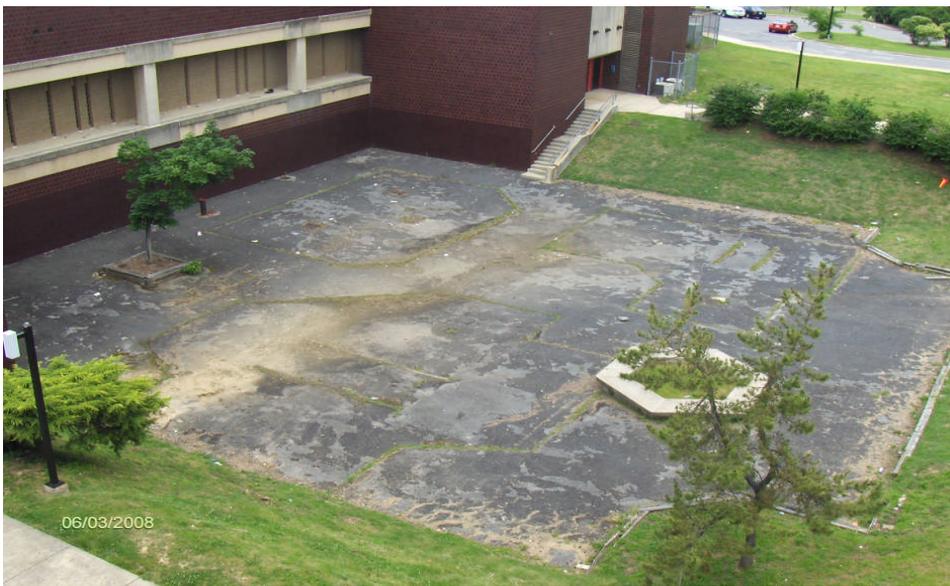
PHOTOGRAPH 7.2:
Front Unused Lot - Severely
Damaged Asphalt

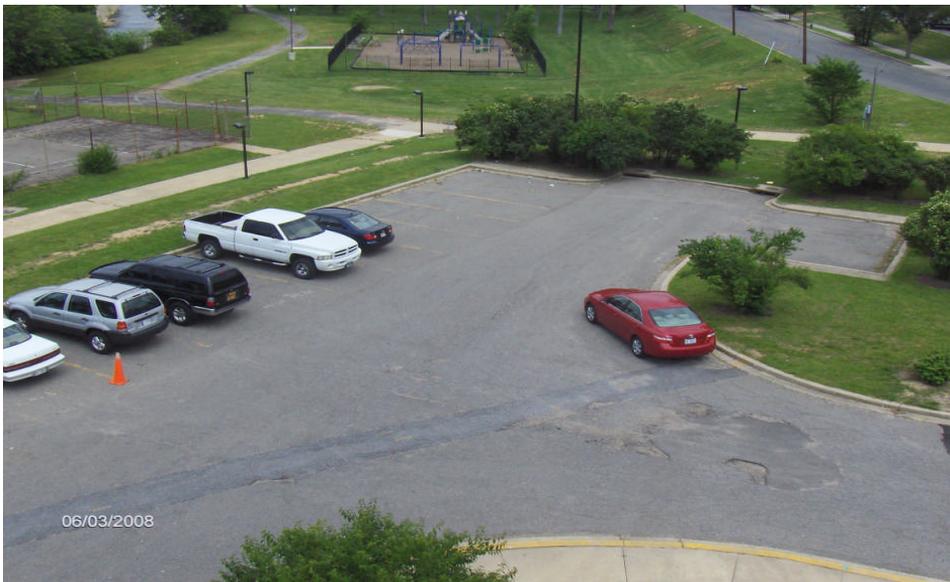
PHOTOGRAPH 7.3:
Parking Lot Near Loading
Dock

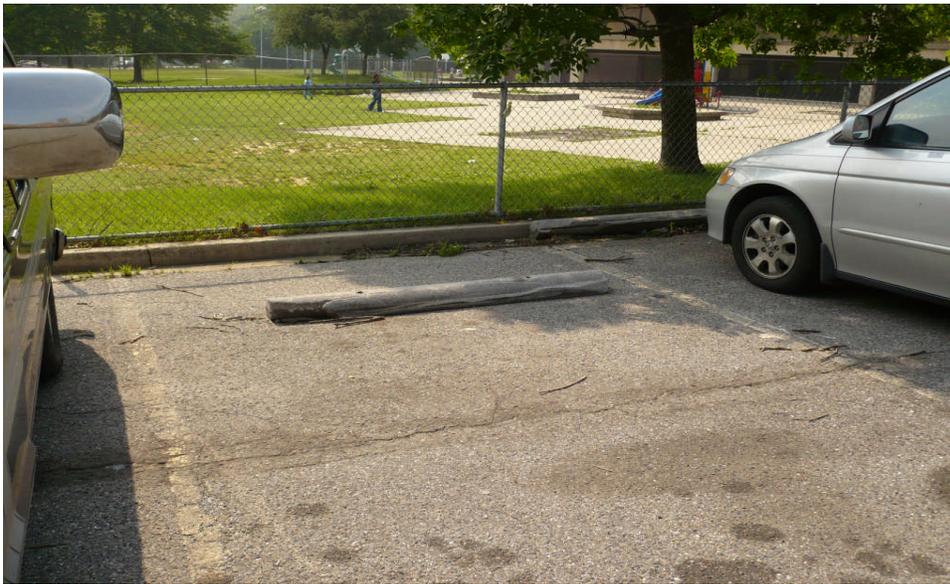
PHOTOGRAPH 7.4:
Damaged Asphalt and
Wheel Stop

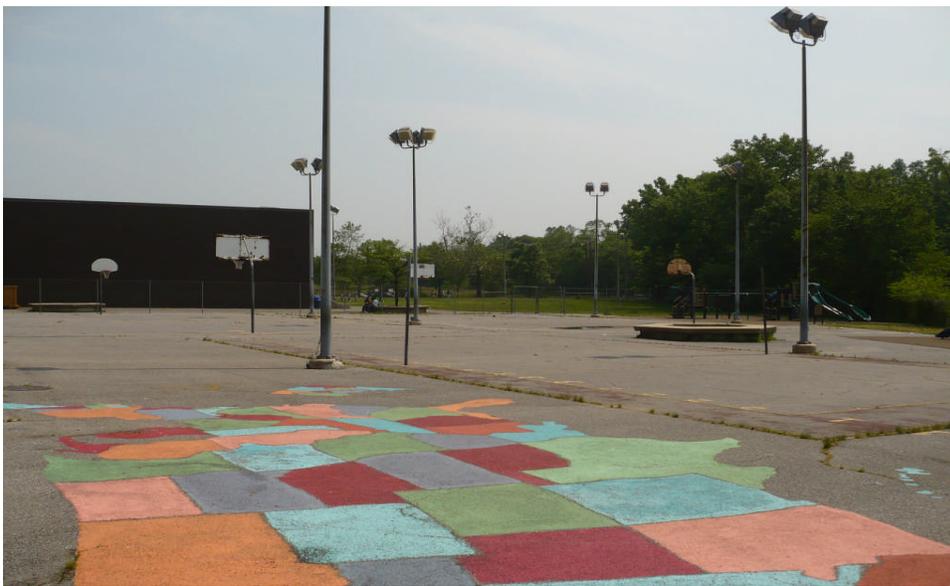
PHOTOGRAPH 7.5:
Typical Playground
Conditions

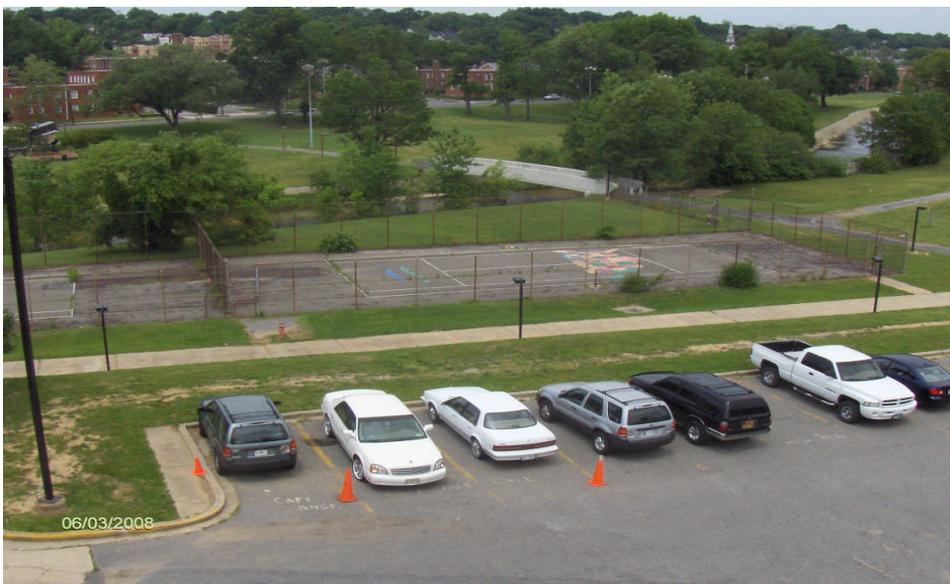
PHOTOGRAPH 7.6:
Tennis Courts - Poor
Condition

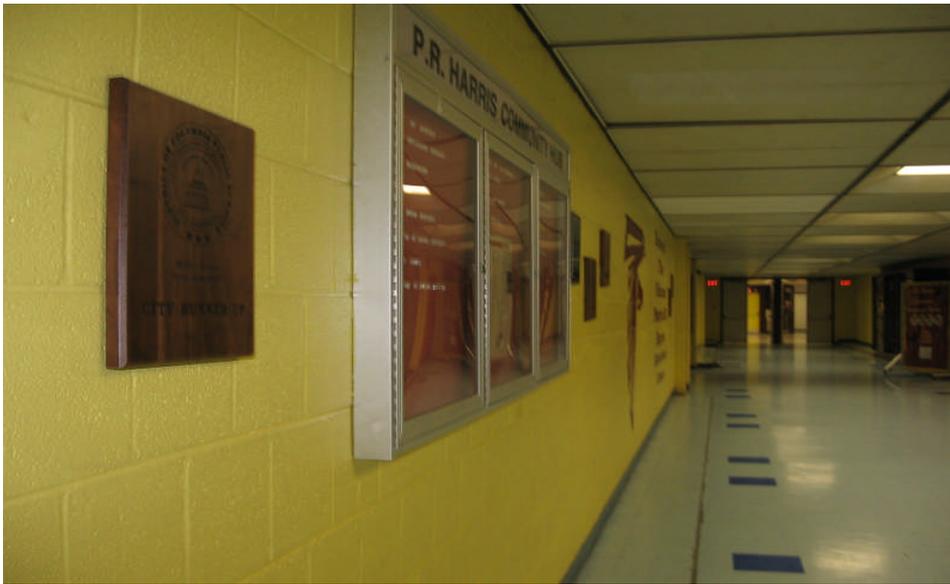
PHOTOGRAPH 8.1:
Typical Construction - CMU
Walls

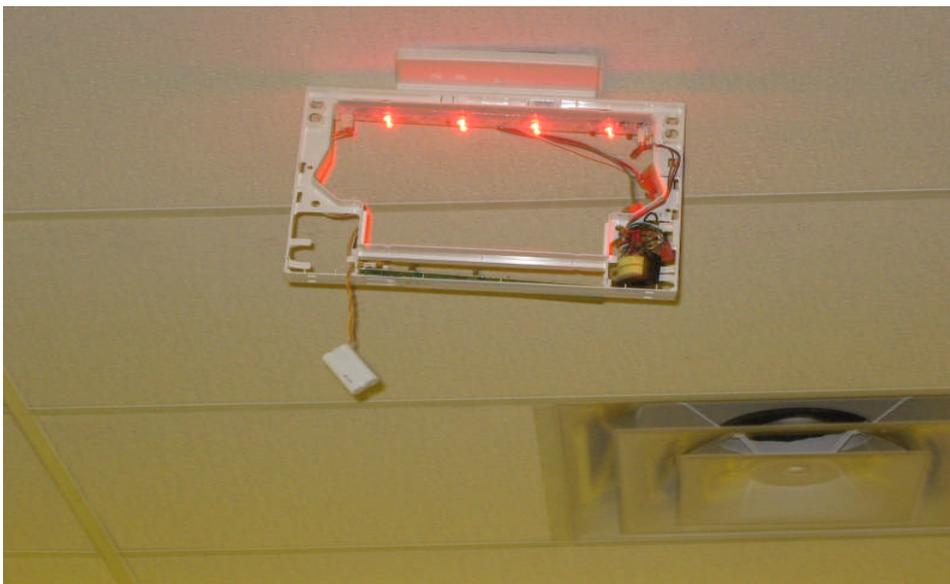
PHOTOGRAPH 8.1:
Broken Exit Sign

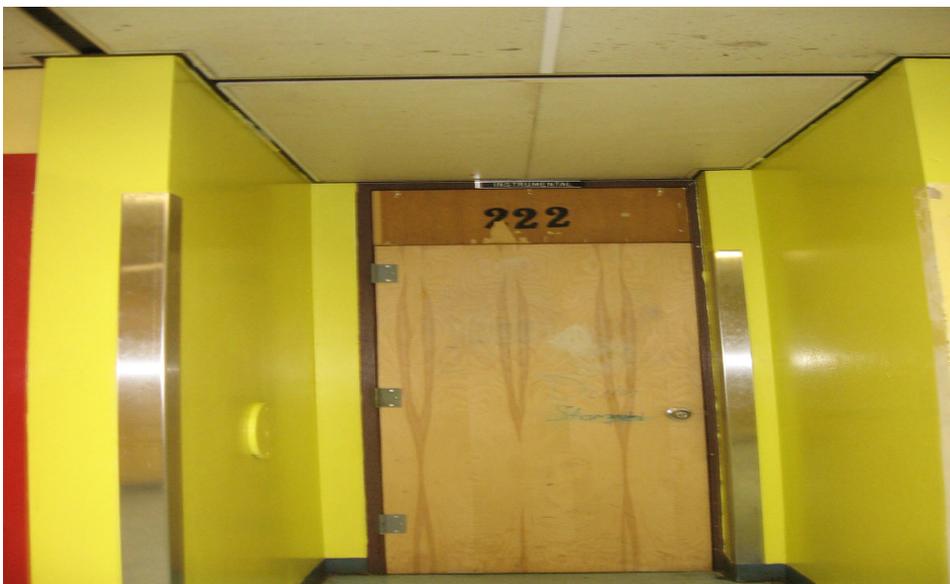
PHOTOGRAPH 8.2:
Non-Compliant Doorway
(Limited Clearance)

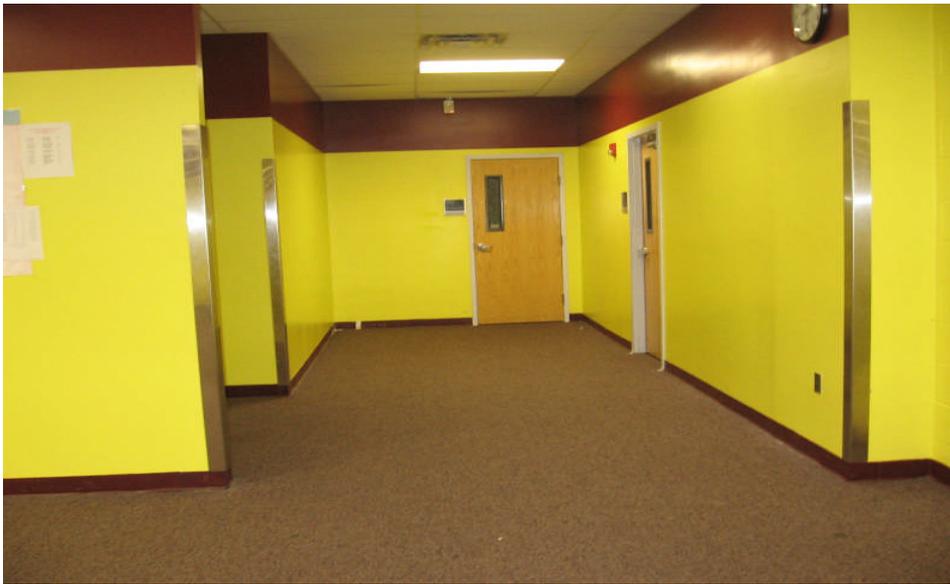
PHOTOGRAPH 8.2:
Typical Construction -
Drywall Walls

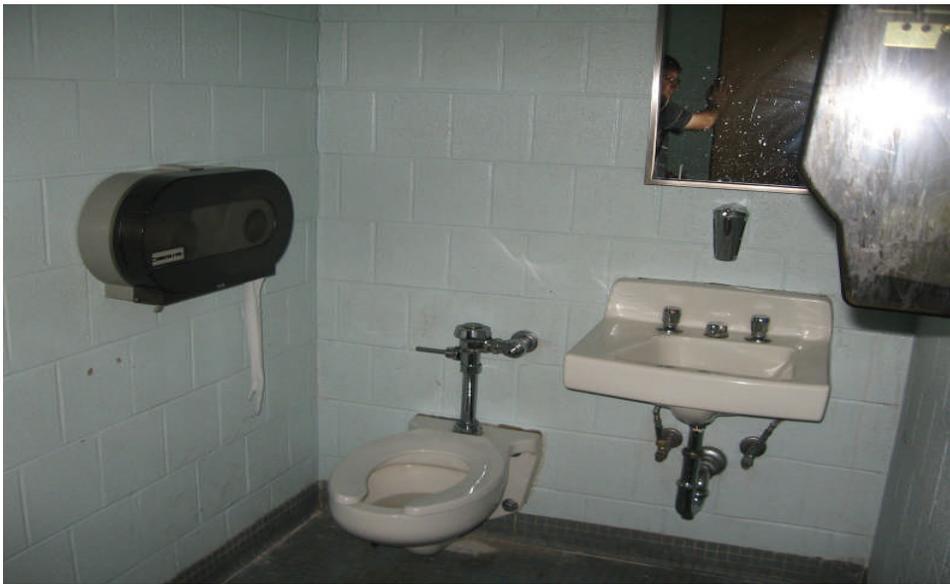
PHOTOGRAPH 8.3:
Handicapped Stall

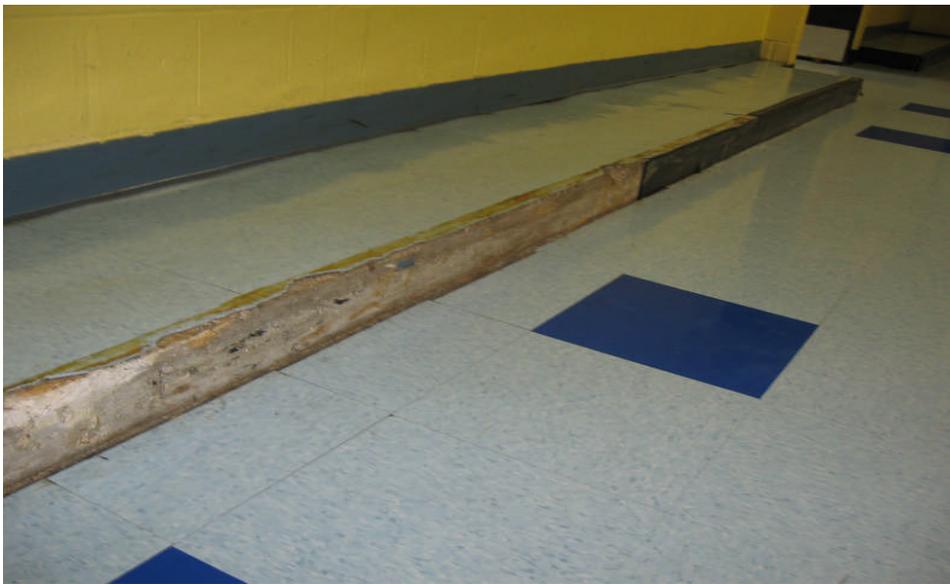
PHOTOGRAPH 8.3:
Typical Floor Finish - Vinyl
Floor Tile

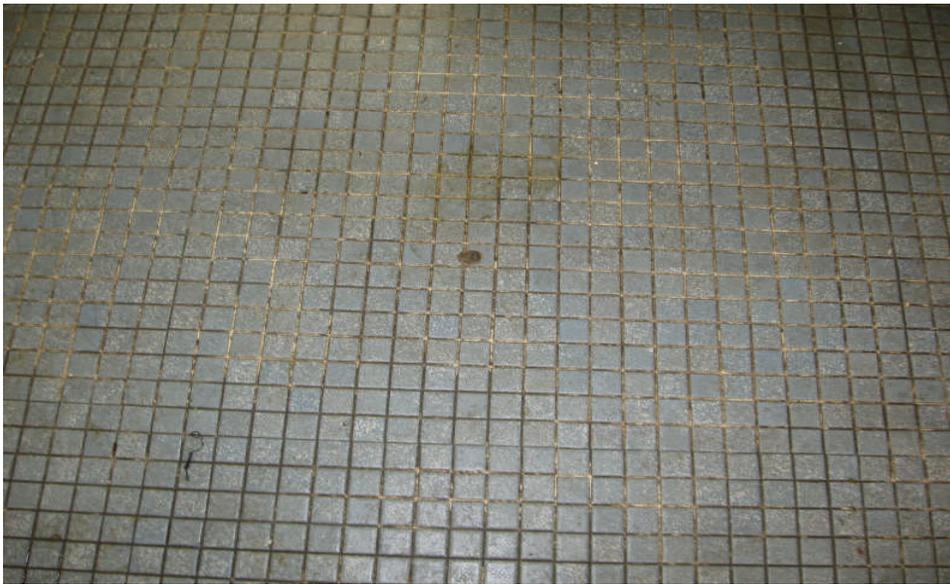
PHOTOGRAPH 8.4:
Typical Restroom Floor
Finish - Ceramic Floor Tile
