Draft Report of Condition Assessment

P.R. Harris Education Center Washington, DC

FEA Project No.: R01.2008.005662

**SUBJECT: Report of Facility Condition Assessment
District Elementary & Middle Schools (Cluster II) – P.R. Harris Education Center
Washington, D.C.
FEA Project No. R01. 2008.005662**

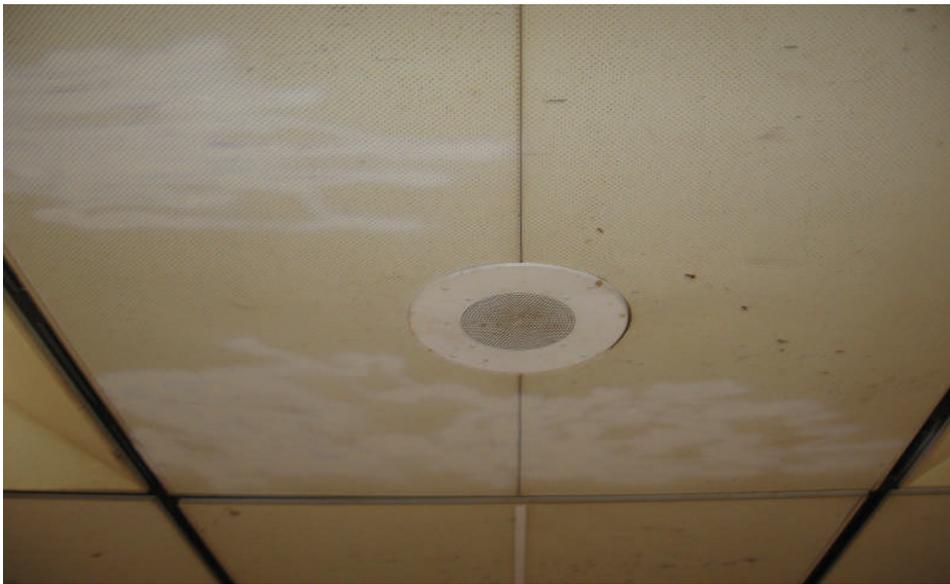
PHOTOGRAPH 8.5:
Typical Ceiling Finish -
Acoustical Tile

- a. Based on observation, it is assumed that 30% of the total surface area of the drywall contains scratches or graffiti. It is recommended that this area is repainted. Opinion of cost is **\$ 55,000**.
- b. Based on our observations, it is assumed that approximately 40% of VCT flooring is missing, cracked, or broken. It is recommended that the damaged VCT is replaced. Opinion of cost is **\$600,500**. This cost does not include tiles that must be replaced due to asbestos content.
- c. It is recommended that all ceramic tiles be replaced. Opinion of cost is **\$340,800**.
- d. It is recommended that the acoustic tile ceiling be replaced. Opinion of cost is **\$865,000**.

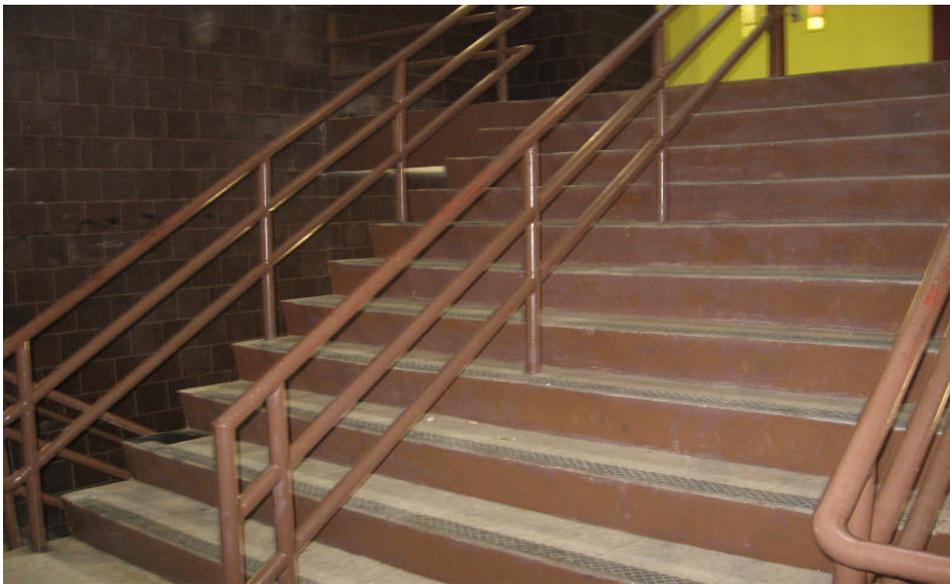
PHOTOGRAPH 8.6:
Typical Stairwell

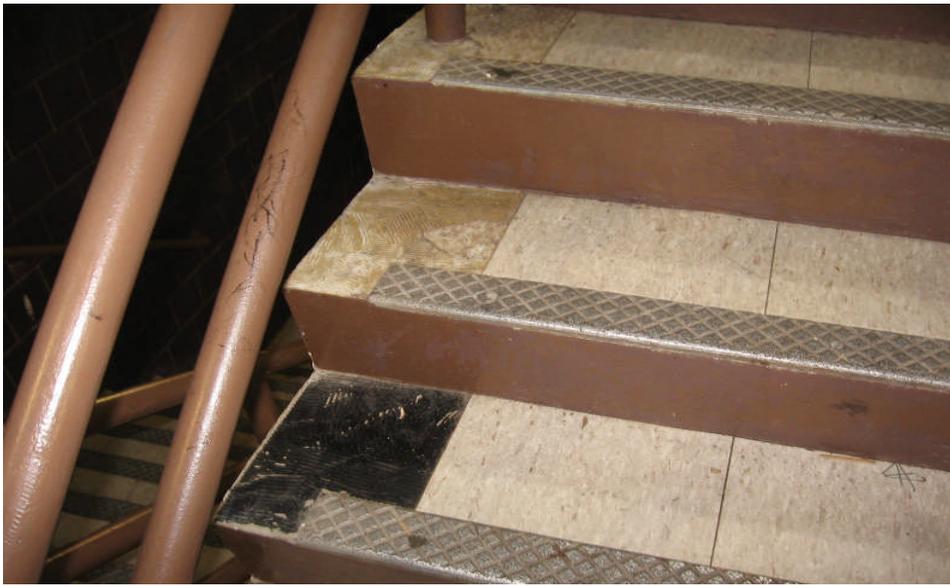
Item	Condition
Building Name	P.R. Harris Educational Center
Stair Construction	
Stairwells (all)	Good condition; no observed structural failure.
Stair Finishes	
Finish 1	Fair to poor condition; instances of dislodged, cracked and broken tiles.
Finish 2	Fair condition; minor instances where nosing was not fastened securely causing potential trip hazard.
Finish 3	Good condition; observed minor peeling.
Other	
Stair railing	Good condition; no observed significant damage or failures.

PHOTOGRAPH 8.7:
Missing Tile from Stairwell

- a. It is assumed that 10% of the total surface area of VCT on the stairwell is dislodged, cracked or broken based on observation. Therefore, it is recommended that 10% of the VCT are replaced. This cost of replacement is included in the cost of replacing damaged VCT in the Interior Finishes section under capital expenditures.
- b. It is recommended that loose metal nosing are fastened. This is a nominal cost and should not be an additional item to the maintenance expenditures. This item is assumed to be included in normal operating expenses.
