WILKINSON ELEMENTARY SCHOOL

MOTEN AT WILKINSON ELEMENTARY SCHOOL

2330 Pomeroy Road SE, Washington, D.C.

CONDITION ASSESSMENT

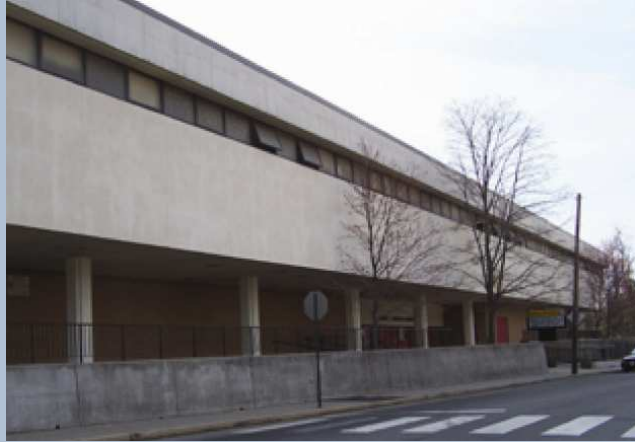
Building System	2008 Rating
ADA Compliance	Fair
Conveying Systems	Fair
Electrical	Fair
Exterior Finish	Fair
HVAC	Fair
Interior Finish	Good
Plumbing	Fair
Roof	Fair
Structure	Poor
Technology	Good

1 Conveying System	There is a functioning elevator in this building. 2008 Receiving School (R/S): Elevator repair.
2 Electrical	Main service, branch circuit panels, and branch circuit wiring are original mid 1970's and in good condition. About 90% of the light fixtures are original 2'x4' fluorescent grid fixtures in fair condition and can be maintained. 2007: General power repairs, replace/repair light fixture. 2008 R/S: Upgraded electrical outlets throughout building as required to support new configuration. New lighting fixtures throughout.
3 Exterior Finish	There is damage in the exterior soffit of the building, under the overhead where the second floor cantilevers out into the space. 2007: Replaced exterior lighting. 2008 R/S: Broken window panes replaced, damaged windows replaced. General exterior elevation cleanup.
4 Structure	A number of structural conditions have been observed which in our opinion required further investigation to properly understand the conditions and to determine the appropriate remedial action to be taken. Three potential structural problems have been observed: 1 - In Stair 210 there is a crack in the wall. 2 - In space #4 there is a concrete beam with exposed rusted steel. 3 - Signs of structural damage were noticed in the northeast corner of space #213. At this location, potential settlement in the foundation and cracks in the wall and ceiling above have been sighted. The space #213 is located in the basement level adjacent to the Boiler Room. Please note that space #213 was discovered when assessing this building. The Basement Plan we originally received did not show this space. It showed "unexcavated". Please review our updated basement plan and notes. We recommending further structural investigation take place.

5 HVAC	Complaints of too hot (winter) or too cold (summer). All air handling equipment is in fair condition but needs to be replaced soon. There is no means of zone controlling causing unacceptable space temperature. 2007: Repairs to Boilers and classroom units. Repairs to AC Central Unit. 2008 R/S: Upgraded system components as required to ensure acceptable operations.
6 Interior Finish	Interior finishes are 40% Poor (flooring, doors, and some walls) and 60% Fair (ceilings and walls). 2008 R/S: New interior partitions, wall coverings, flooring, ceiling system and ceiling tiles, new doors, hardware, etc., as required to support new configuration. 2009: Received health suite renovation to comply with Department of Health guidelines.

7 Plumbing	Plumbing is in fair condition. All of the student's toilets are ADA compliant while the adult's toilets are NOT. Some fixtures needed to be upgraded or replaced. 2008 R/S: Upgraded system components as required to ensure acceptable operations. New restrooms as required to support new configuration.
8 Roof	The roof generally is in fair condition, but there are isolated repairs that are required to prevent further deterioration of interior finishes. 2008 R/S: Repaired / replaced leaking roof portions, including flashing, gutters, downspouts and roofing membrane.
9 ADA Compliance	The building is accessible to handicapped persons and there are handicapped bathrooms within the building, however there is a need for adult ADA compliant bathrooms and a minor upgrading of fixtures and faucets in some of the bathrooms. 2008 R/S: New door hardware, all restrooms are ADA-compliant.
10 Technology	Data and video drops are available throughout the facility. Not all rooms were equipped with PC's and TV's. Intercom system is original and should be replaced/ modernized. 2008 R/S: Repairs to P.A. system throughout the building, new computer connectivity to all new classrooms, library, and media center, etc.

11 Grounds	Elastomer joint filler at retaining wall expansion joints has deteriorated. As a result, soil, water, and vegetation behind the wall protrude through these joints located approximately 60' on center. The playground area needs to be milled and resurfaced to remove remnants of previous playground equipment that poses health and safety issues. Site trees in the playground appear dead and have mold growing on the trunks. Hand rails through the grounds are rusted and need galvanized paint. In general the grounds and athletic fields are in very poor condition. 2008 R/S: New parking area and driveway A/C paving and striping, repair damaged concrete hardscape.
